**CONSOLIDATED METCO, INC
CSM Site Summary**

CONSOLIDATED METCO-RIVERGATE (CONMET) FACILITY

Oregon DEQ ECSI #: 3295

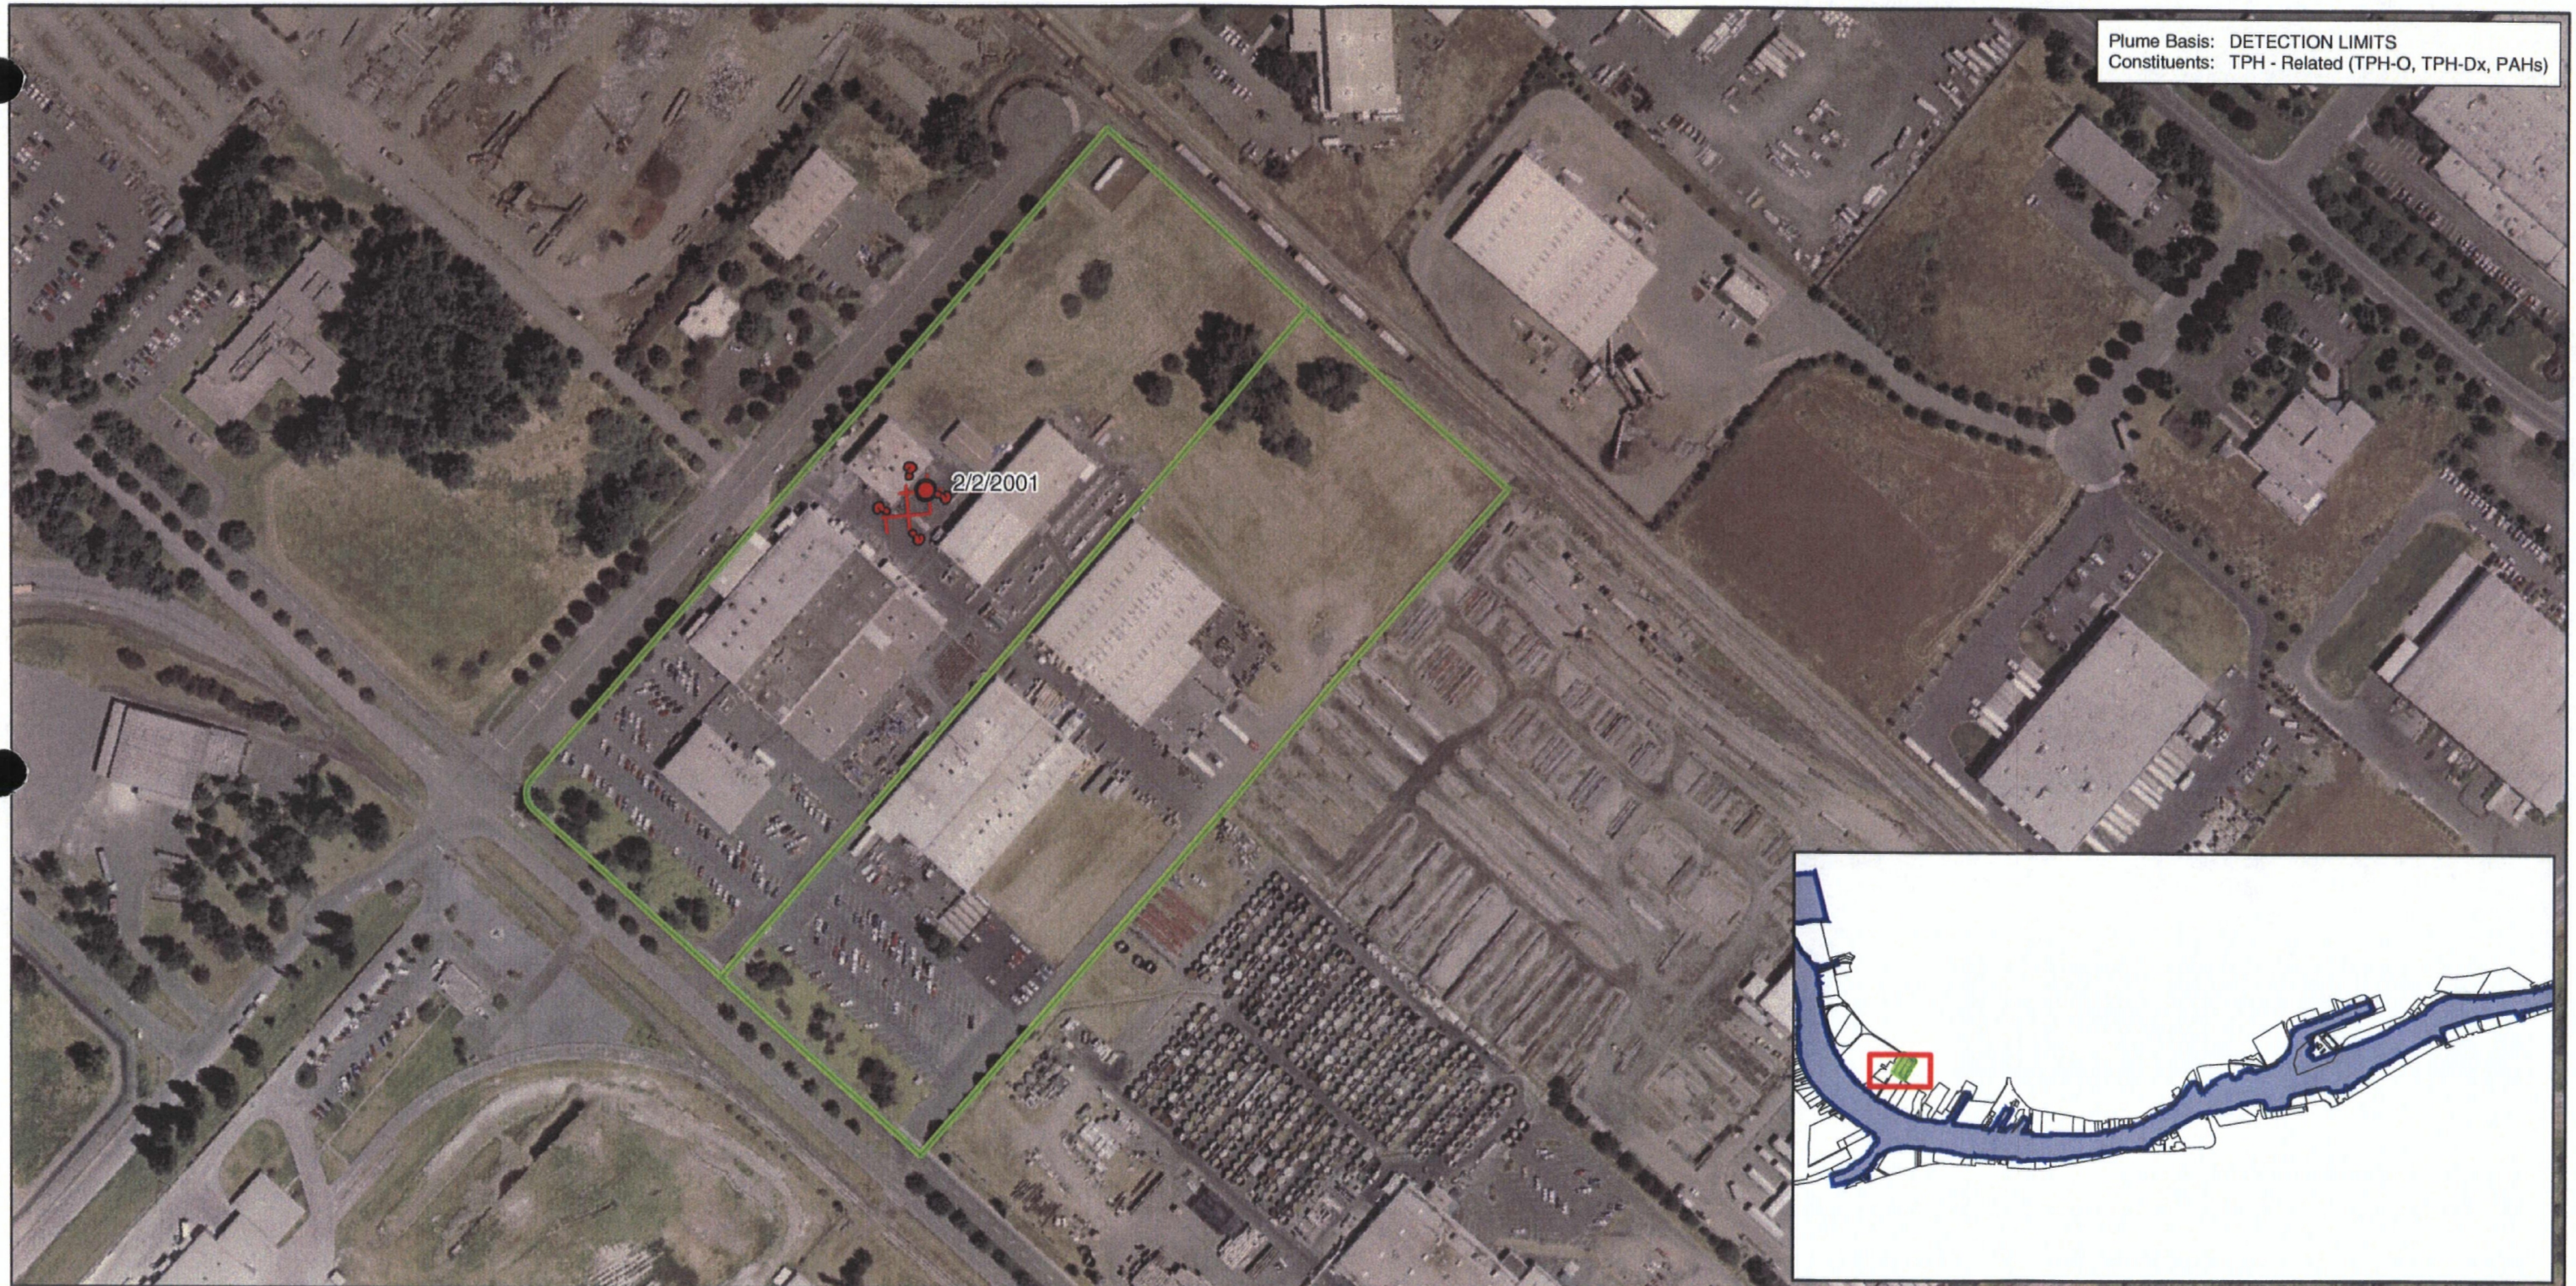
Figure 2
Portland Harbor RI/FS
Consolidated Metco, Inc.
Upland Groundwater Quality Overview

A dissolved groundwater plume is present in the shallow aquifer beneath the site. Diesel-range TPH and oil-range TPH were detected in all six groundwater samples, with concentrations ranging from 0.580 µg/L to 40,700 µg/L (*see note above*). Five PAH compounds (acenaphthene, fluoranthene, fluorene, phenanthrene, and pyrene) were detected in two of the four groundwater samples analyzed (DEQ 2003).

Based on the data reviewed by GSI, the estimated extent of the petroleum plume in the shallow aquifer is shown in Figure 2.

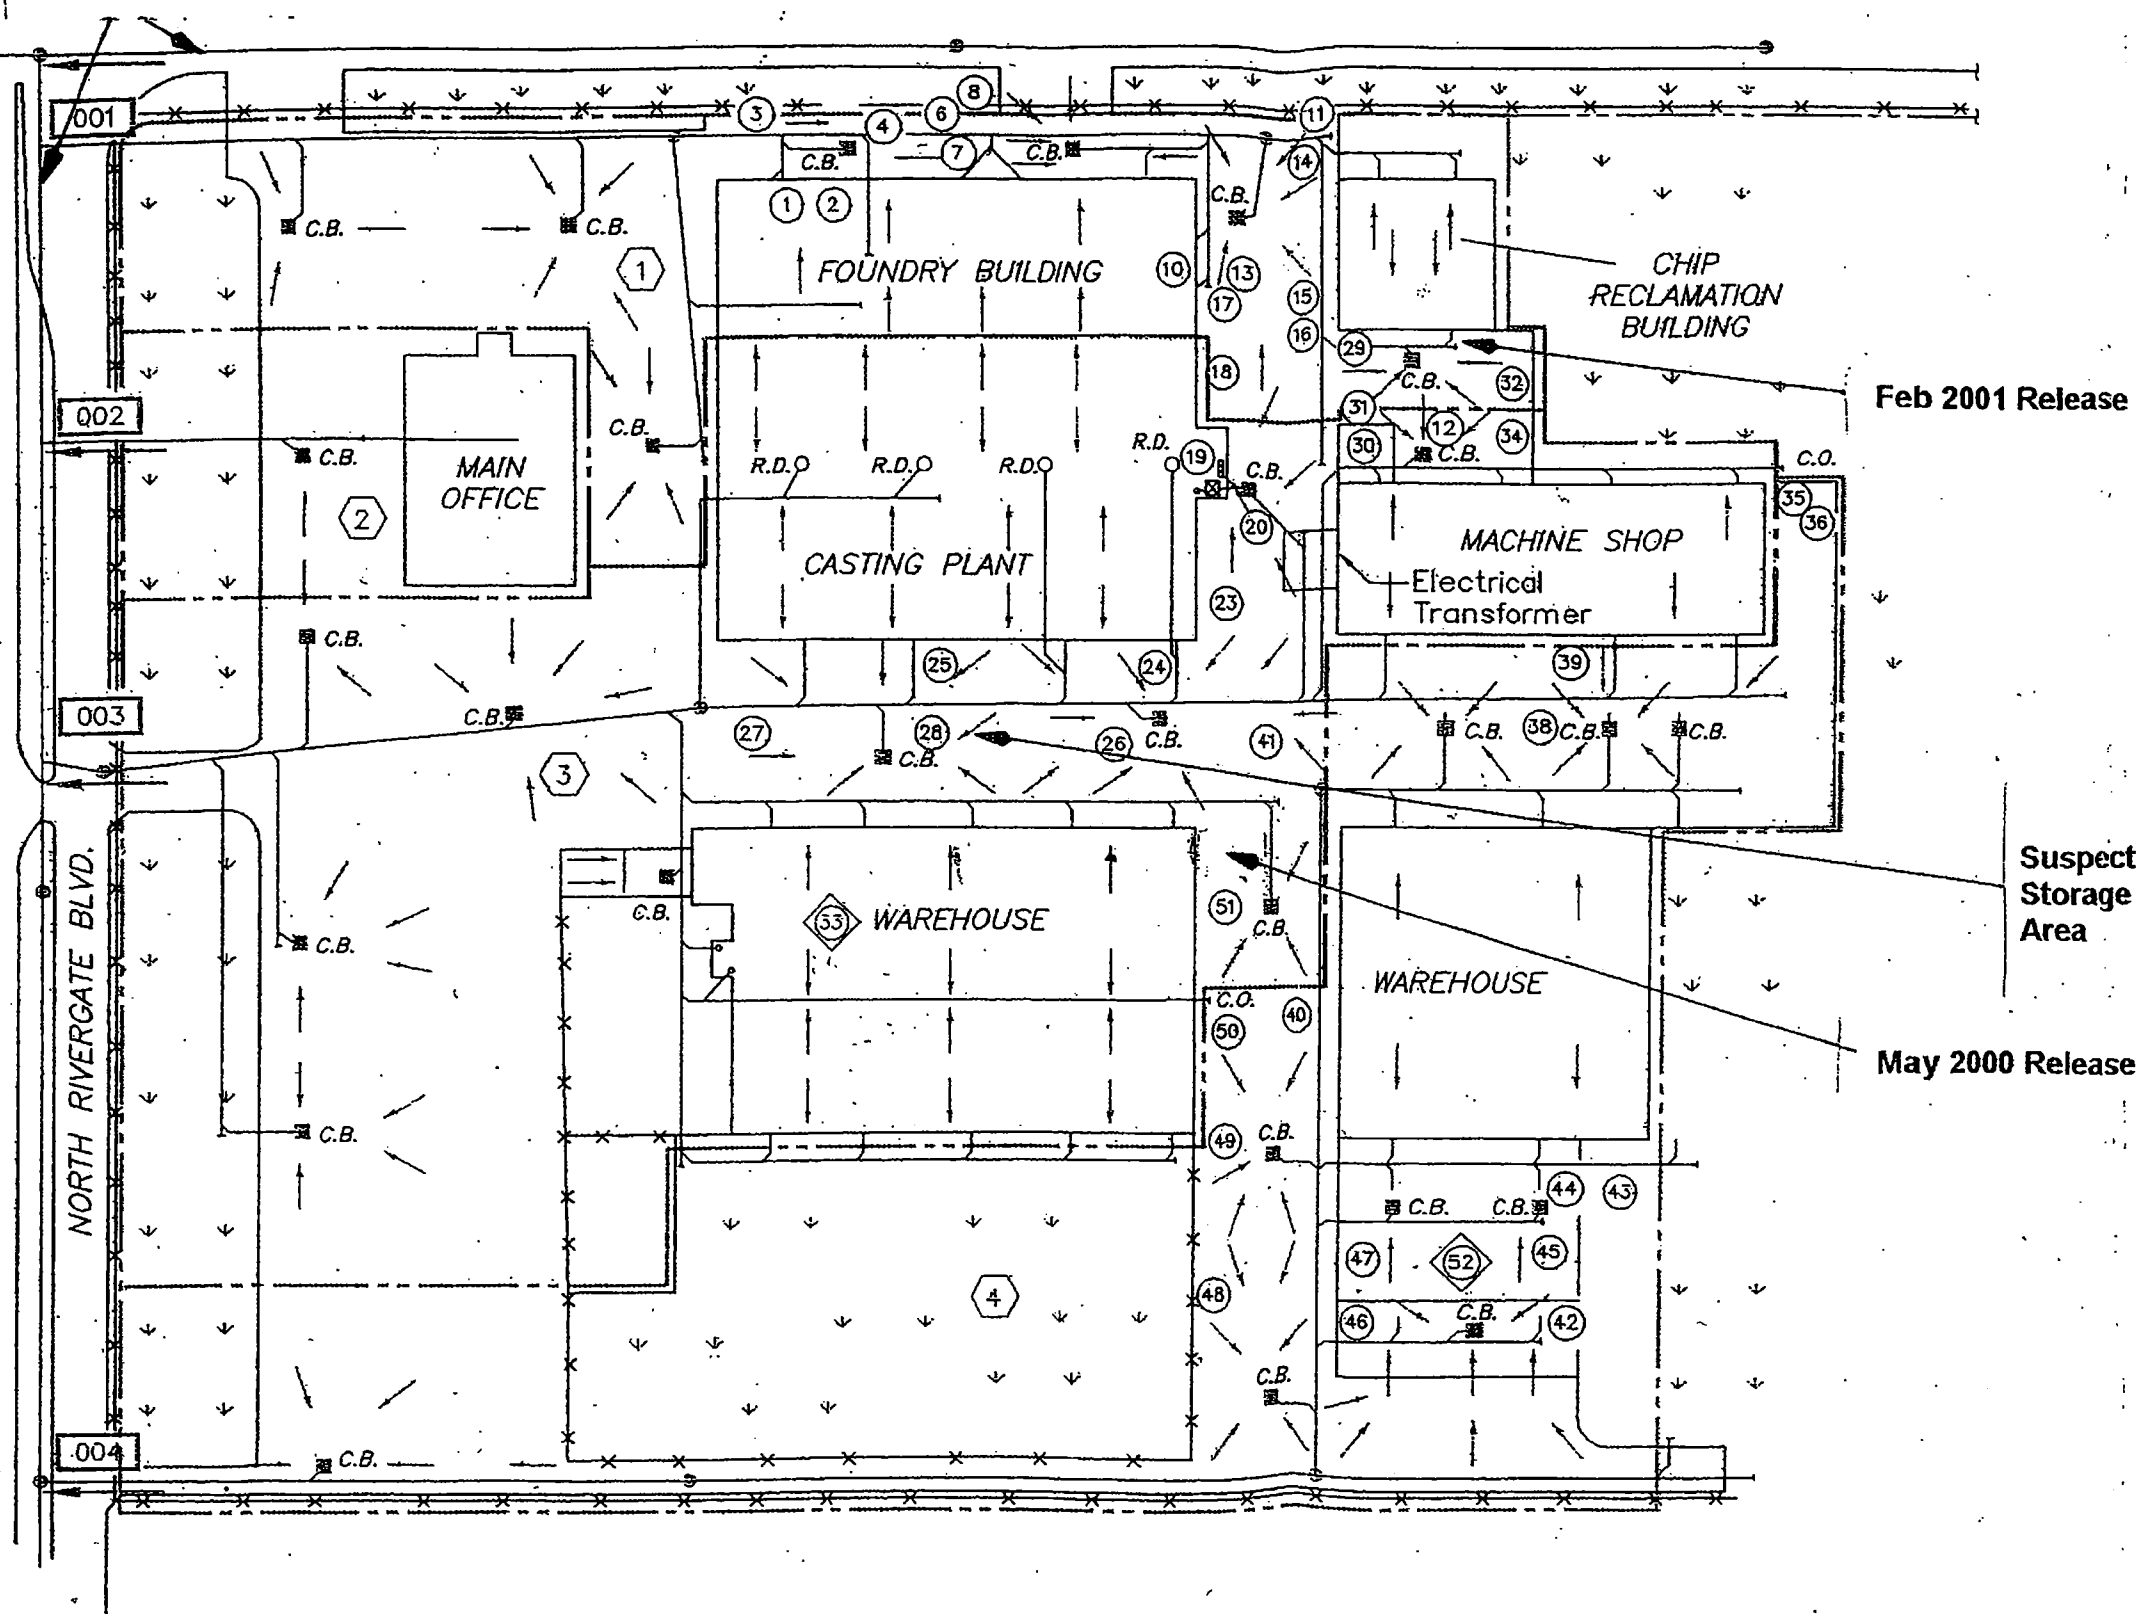
Figure 3
On-Site Stormwater Map

The location of these structures is shown in Supplemental Figure 3 from DEQ (2003). This figure also identifies the layout of the stormwater drainage system for the site including the location of catch basins either with or without filtering devices.

Stormwater drains through four catch basins on the site that discharge through an outfall to the Willamette River. As described in previous sections, the stormwater conveyance system has acted as a preferential pathway in the past [see Supplemental Figure 3 from DEQ (2003)].

There is potential for industrial materials to be released into the river because the stormwater conveyance system has acted as a preferential pathway in the past [see Supplemental Figure 3 from DEQ (2003)].

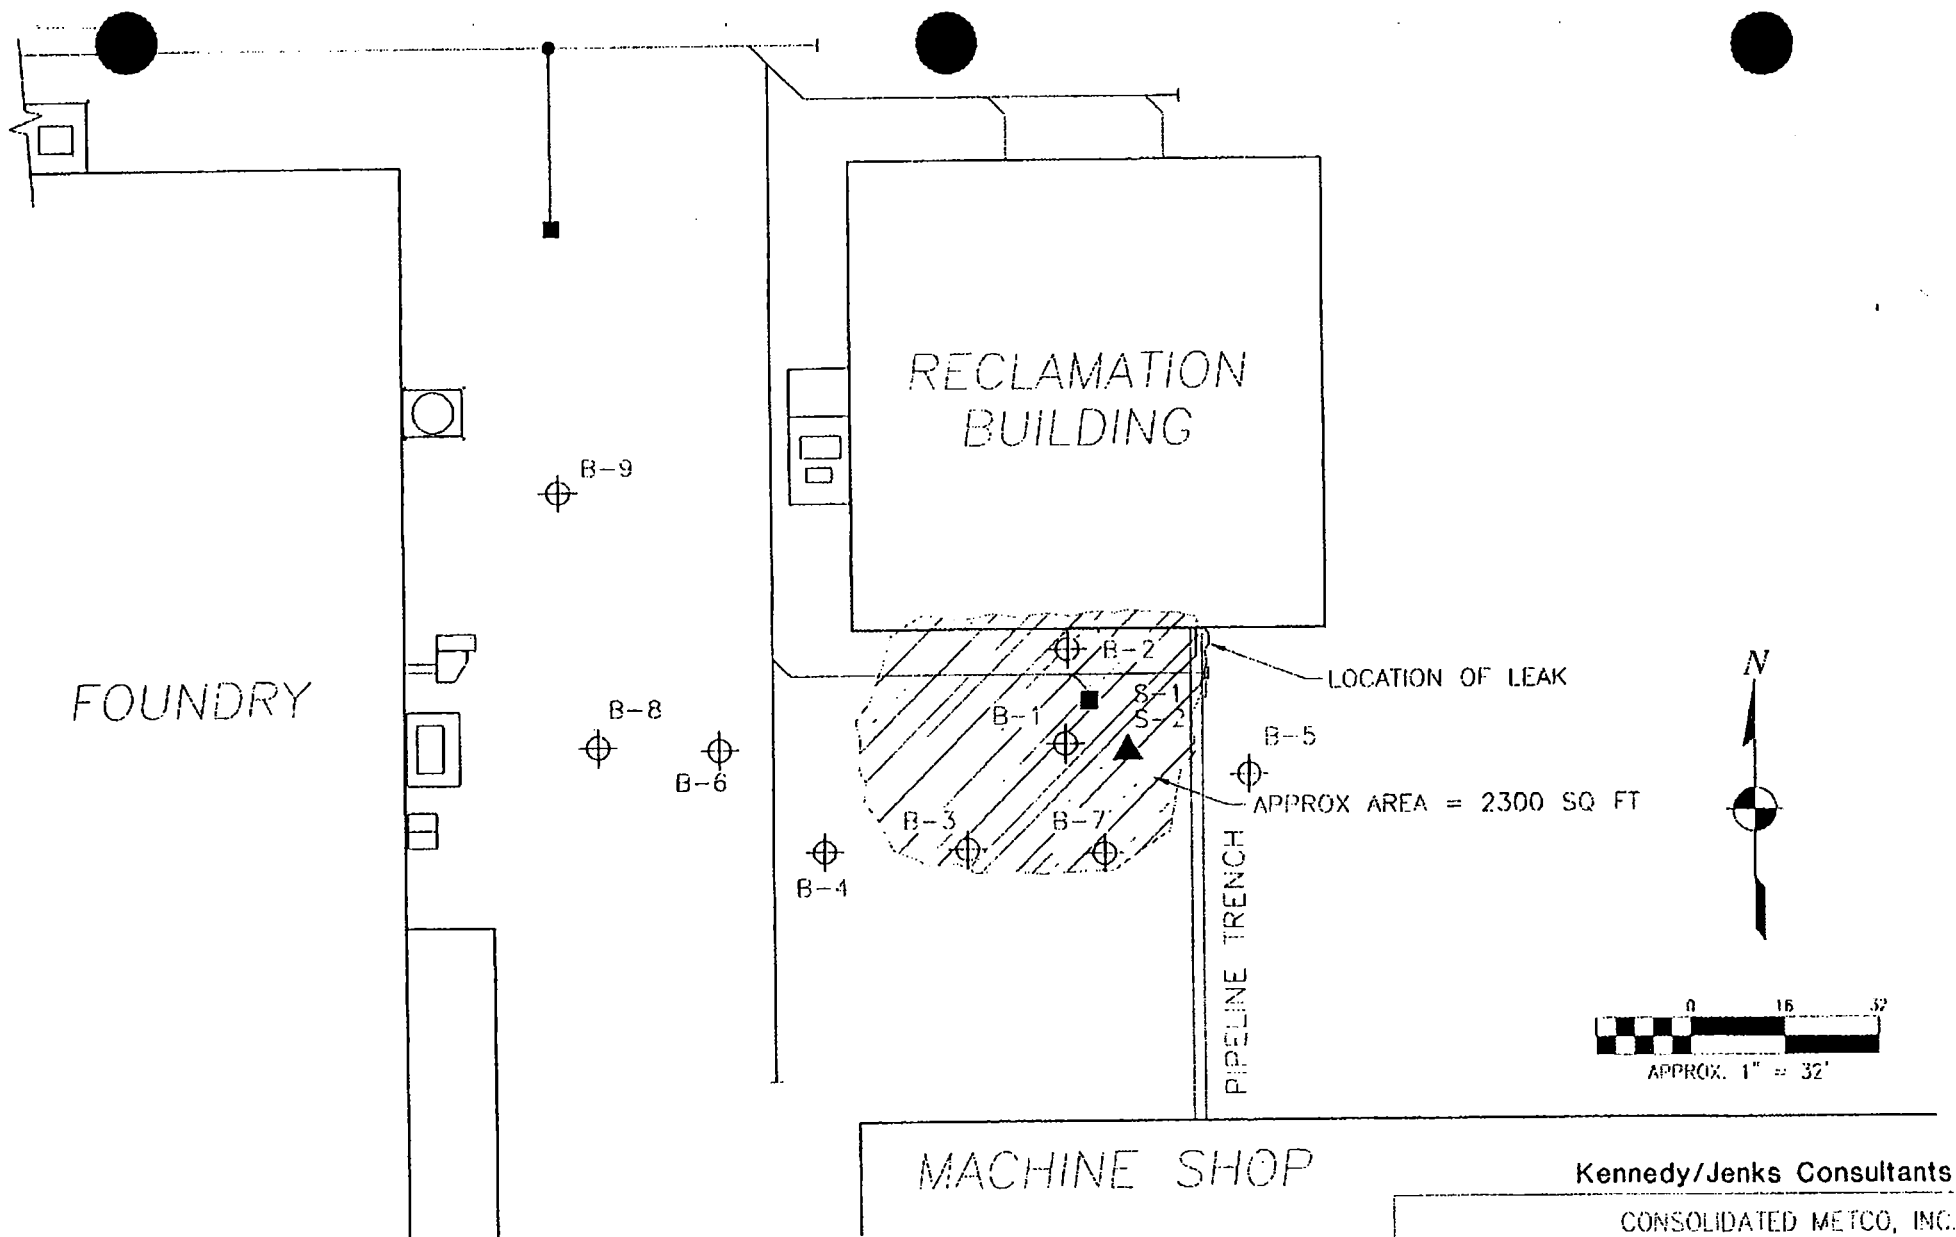
SITE PLAN SHOWING IMPACTED AREA

As mentioned in Section 1, a release of reclaimed cutting fluid occurred in February 2001. The release was caused by a split in a pipe connection where galvanized piping connects to the polyvinyl chloride (PVC) pipeline that runs between the reclamation building and the machine shop [see Supplemental Figure 3 from DEQ (2003)]. The pipe connection occurs at a depth of

approximately 2 feet bgs (Kennedy/Jenks 2004). The incident investigation notes that released cutting fluids infiltrated fill materials. Once the perched aquifer zone became saturated, the contaminated groundwater leaked up through a crack in the asphalt paving surrounding a cover frame to a nearby stormwater catch basin. Approximately 80 gallons were unrecoverable and were transported to the river via porous gravelly substrate surrounding the stormwater collection system. The contaminated water may also have been released through cracks between sections of the stormwater piping into the gravel pipe bedding (DEQ 2003).

Results also indicated that the released fluid infiltrated fill materials surrounding the recirculation pipes. The contaminated fill material was excavated (15.5 tons) by ConMet's contractor and transported offsite for disposal [see Supplemental Figure 1 from Kennedy/Jenks (2004)]. This investigation also addressed a smaller release of cutting fluid (200 gallons) to asphalt in May 2000 (see Section 9).
